## **MARINE INVESTIGATION REPORT**

**M99W0145**

### **GROUNDING**

**BULK CARRIER “MANDARIN ARROW”**

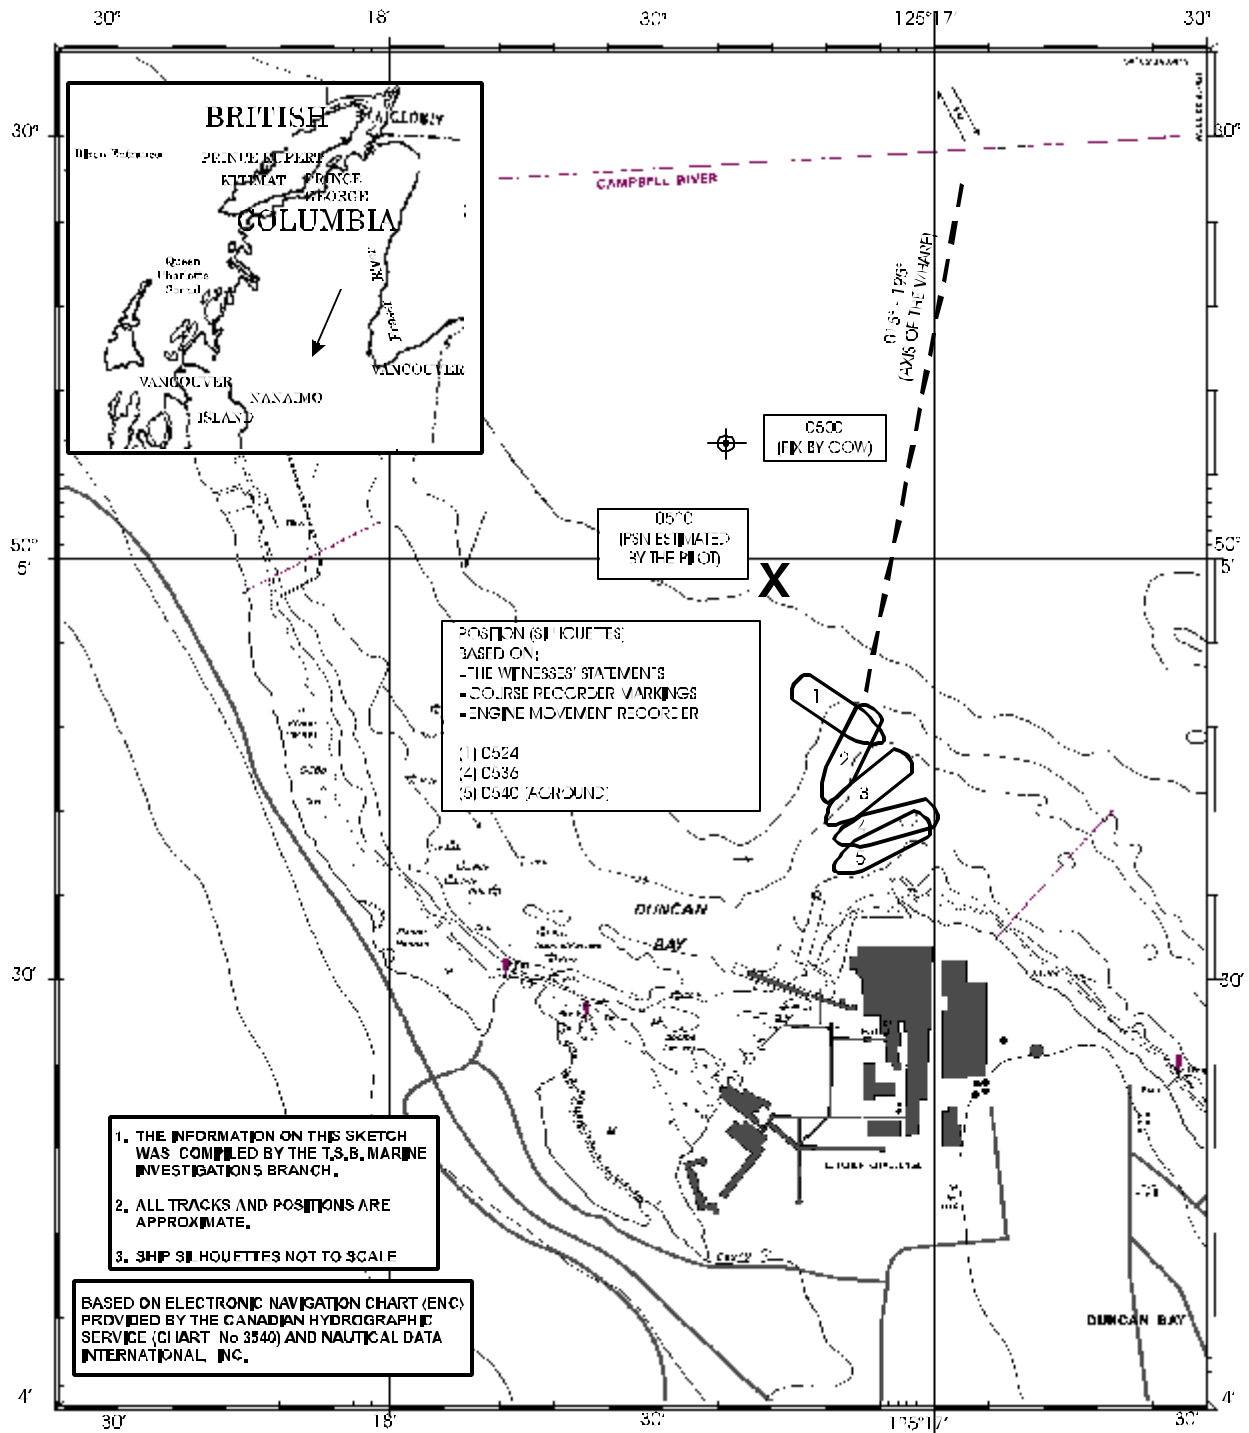
# Appendix A — Sketch of the Occurrence Area

Duncan Bay is a body of water in Johnstone Strait lying approximately four miles south of Seymour Narrows. It is bounded by Vancouver Island to the west and open to the northeast. Located in Duncan Bay is a large pulp and paper mill which owns and manages three wharves: a pulp wharf, a paper wharf, and a barge-loading facility. The pulp wharf, to which the “MANDARIN ARROW” was allocated, is 152 m long and extends into the bay at 15 degrees True (°T), almost parallel to the shore; it has a mooring dolphin located at its north end (see Appendix A).

Canadian Hydrographic Service (CHS) charts used on board the “MANDARIN ARROW” —CHS 3539 and CHS 3540—show several arrows delineating the currents during flooding and ebbing phases of the tide (see Appendix A). One arrow is placed just north of the pulp wharf in Duncan Bay. It shows the ebbing current in an easterly direction. There is no matching arrow referring to the flooding current in the vicinity of the wharf, although all other references to the tidal currents on the chart are paired.

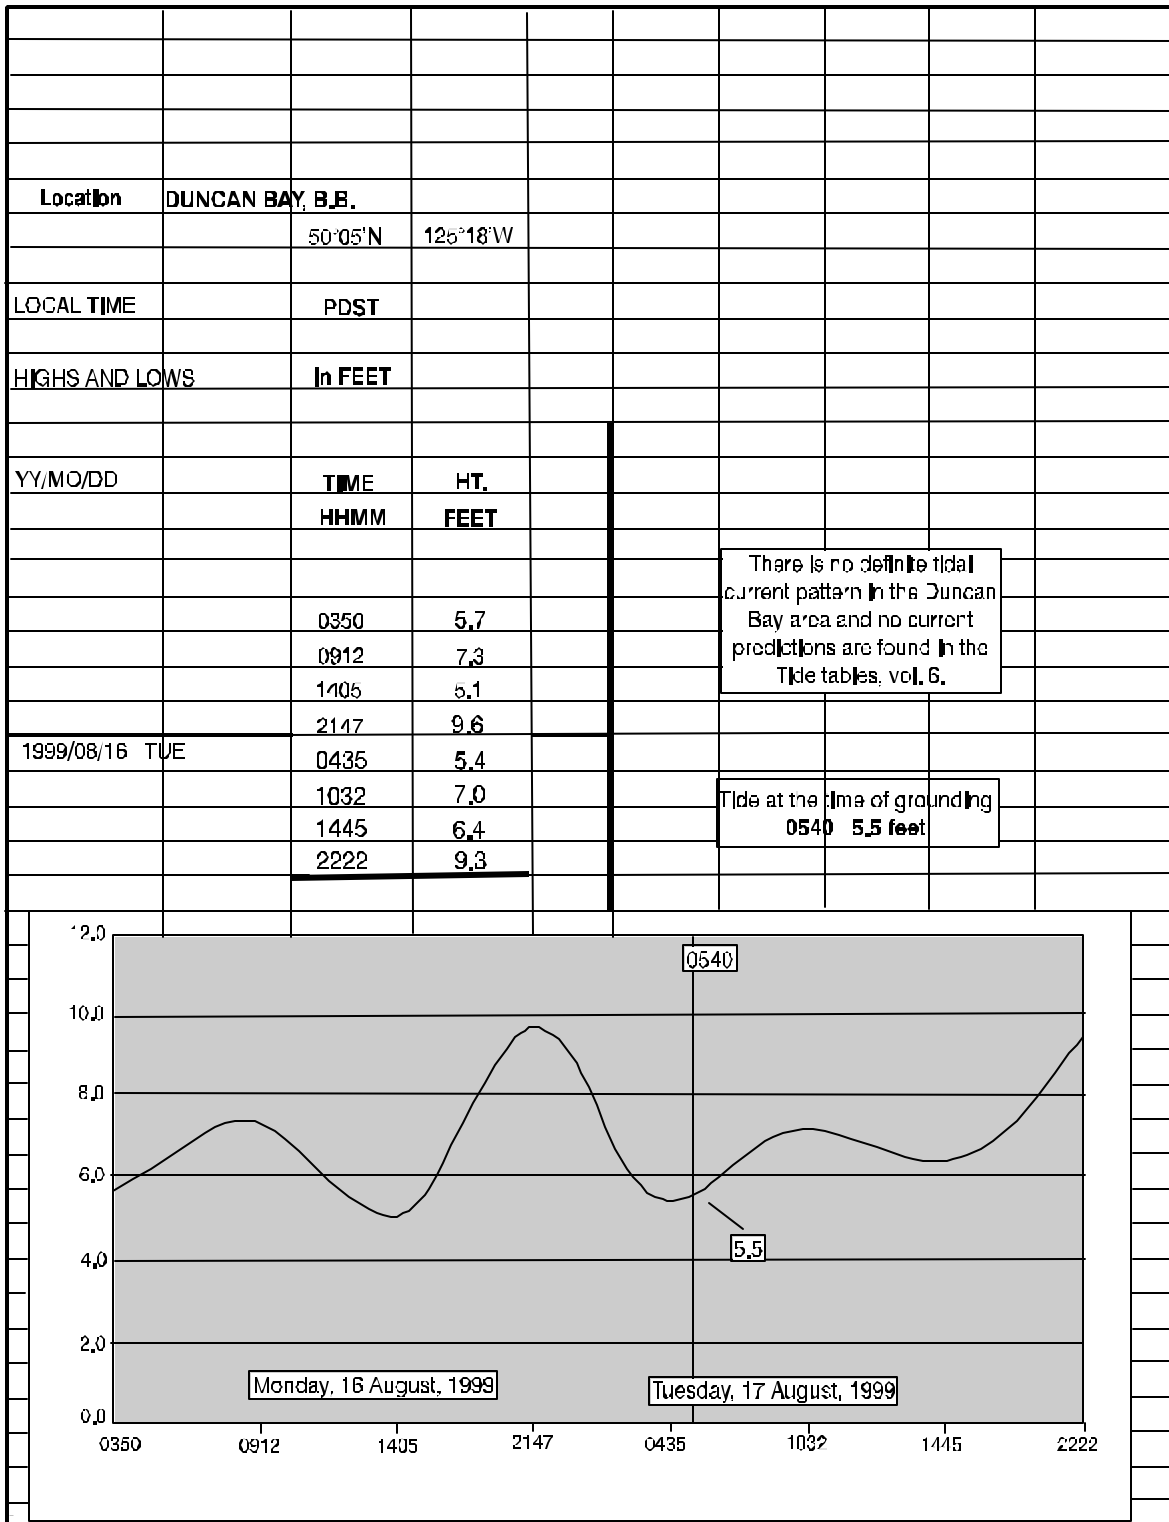
## Appendix B — Tidal Calculations

According to the *Canadian Tide and Current Tables*, Volume 6, the tide at Duncan Bay was rising at the time of the occurrence, with low water predicted to be at 0435, and high water at 1032 (see Appendix B). This suggests the beginning of a flooding current; however, according to information obtained from the CHS, the current flow in Discovery Passage is driven by the difference in water level between the Strait of Georgia and Johnstone Strait. The relationship between the water level in Duncan Bay and the current in Discovery Passage is a complex and unpredictable one; the state of one cannot be inferred from the state of the other.

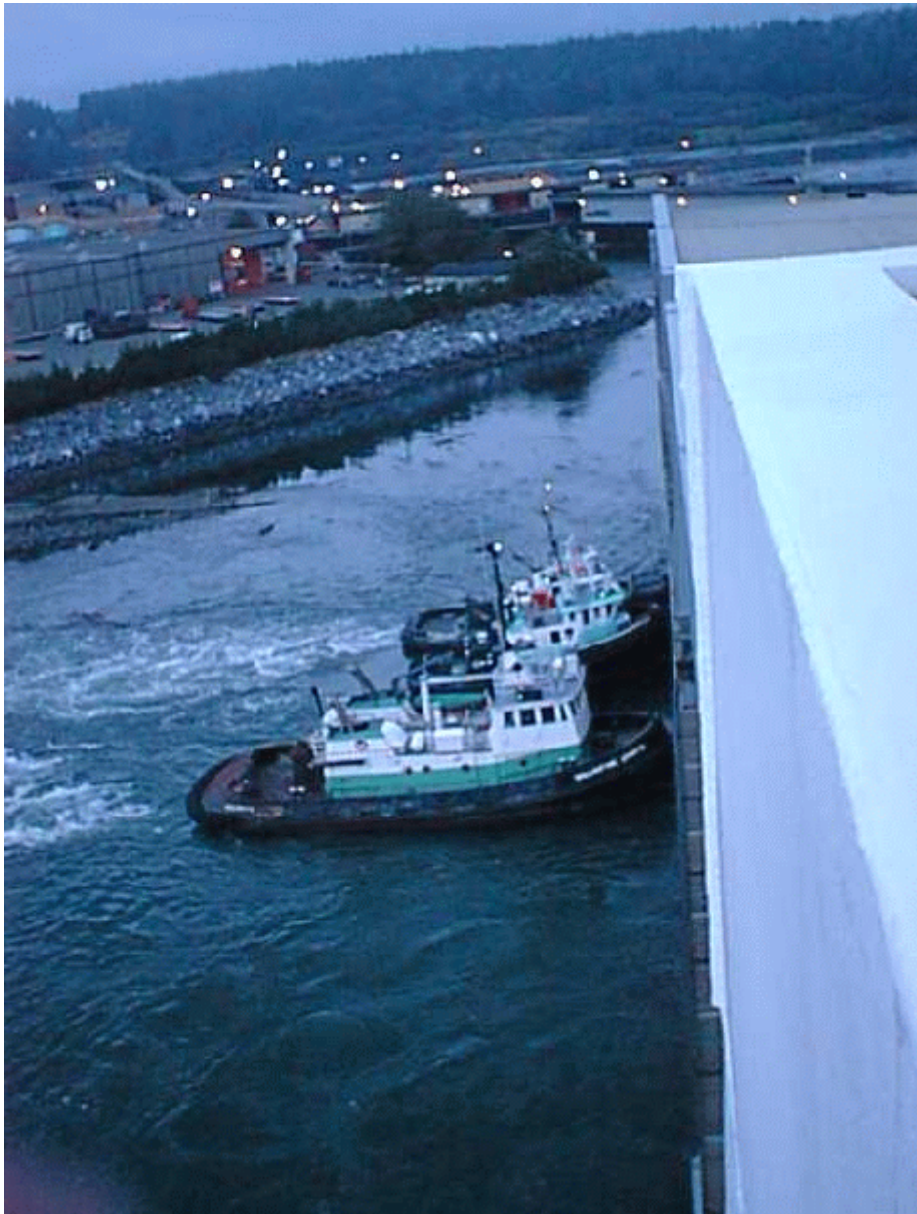
The "MANDARIN ARROW" on 17 August 1999, soon after the grounding, with the tugs pushing onto the port side of the vessel.

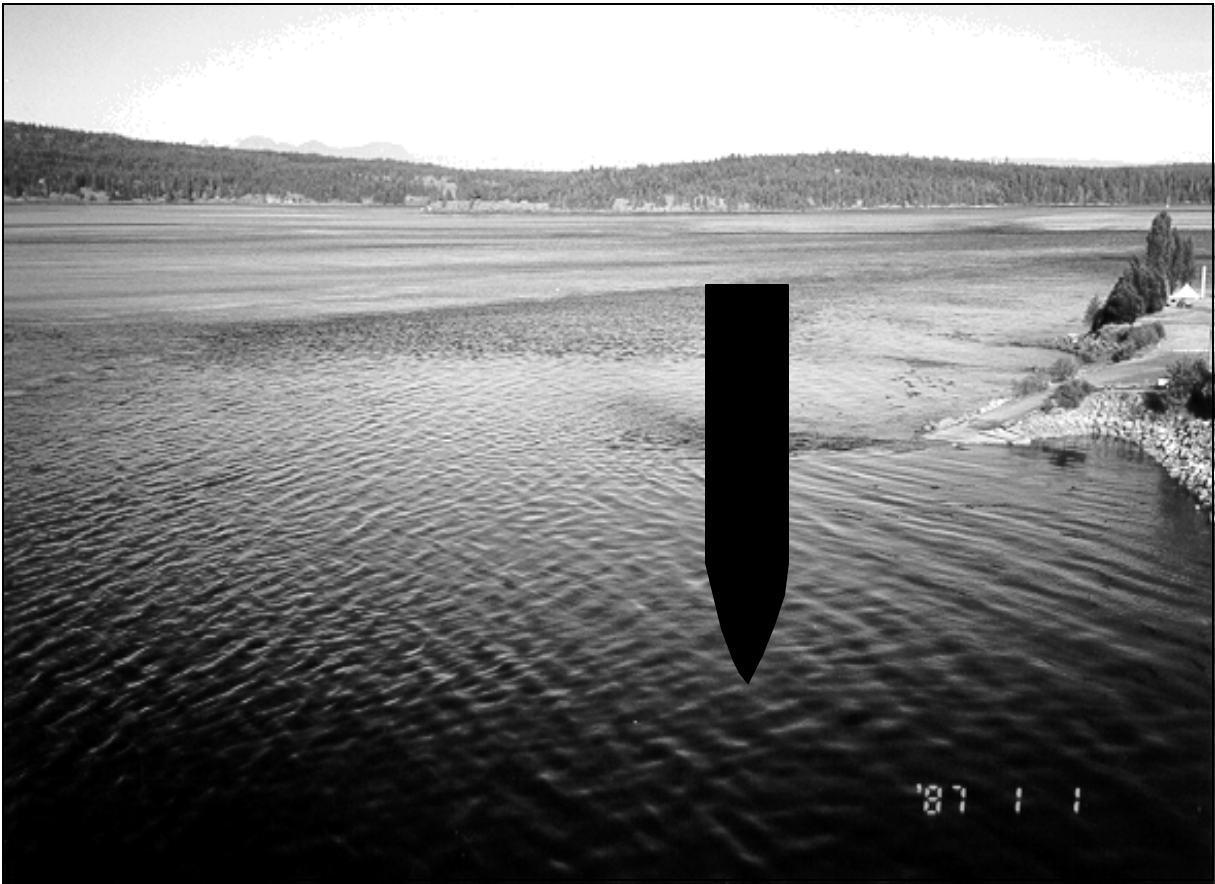
Silhouette shows approximate position of the "MANDARIN ARROW" during grounding.
